**DAM INSPECTION CHECKLIST
POSSUM POINT POWER STATION
POND ABC**

INSPECTION DATE: MARCH 1, 2016

INSPECTED BY: K. ACREE

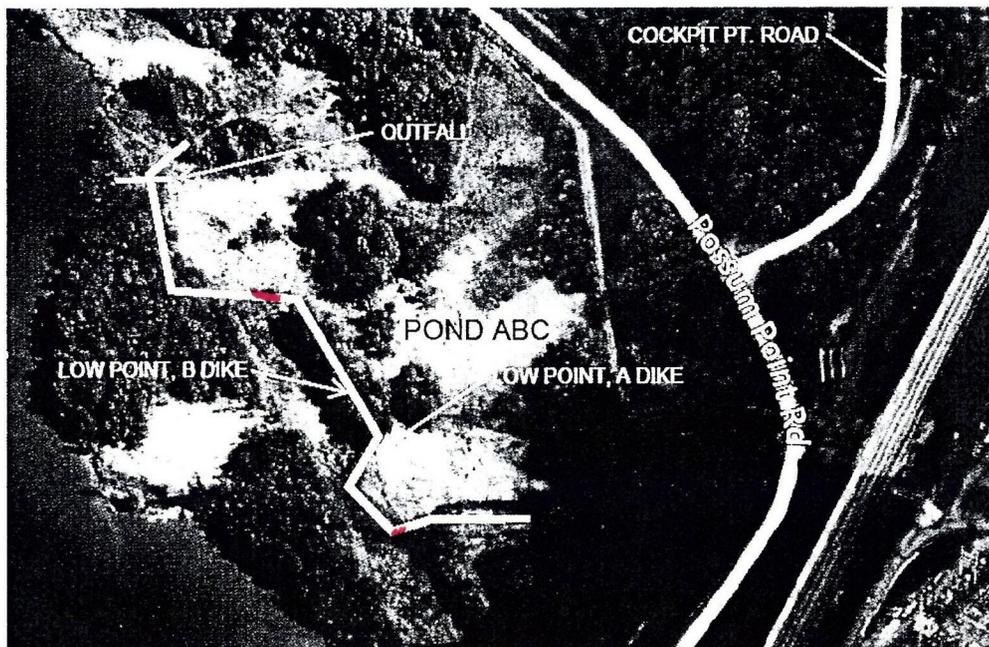
Location/ Condition	(y/n)	Change (y/n)	Comments
Low Point, A dike*			
Flow	N	N	913 → SAND BAGS AND RIPRAP ARE IN PLACE. NO STANDING WATER AGAINST SAND BAGS.
Erosion	N	N	SEVERAL SAND BAGS ARE RIPPED.
Low Point, B dike*			
Flow	N	N	915 → SAND BAGS ARE IN PLACE AND THERE IS NO STANDING WATER AGAINST SAND BAGS.
Erosion	N	N	A FEW SAND BAGS ARE RIPPED.
Outfall water surface El. (top of stoplogs to water)			924 → NO STANDING WATER AGAINST WEIR, NO FLOW THROUGH WEIR, AND THE WEIR APPEARS TO BE <u>DRY</u> .

Additional Comments (Note any changes observed along the embankment crest or downstream slope observed from the crest.): LOW POINT, C DIKE → 921 → SAND BAGS ARE IN PLACE, NO STANDING WATER AGAINST SAND BAGS, AND SEVERAL SAND BAGS ARE RIPPED.
 → STANDING WATER AT INSIDE TOE OF POND A EMBANKMENT (TYPICAL FOR POND ABC)
 → STANDING WATER AT TOP OF EMBANKMENT OF PONDS A, B, & C. (NOTED ON FIGURE BELOW)
